Manhole Inspection Summary

Manhole # S33AA1034MH

Location Address: **JOHN HOPKINS UNIVERSITY**

Cross Street: **CHARLES ST**

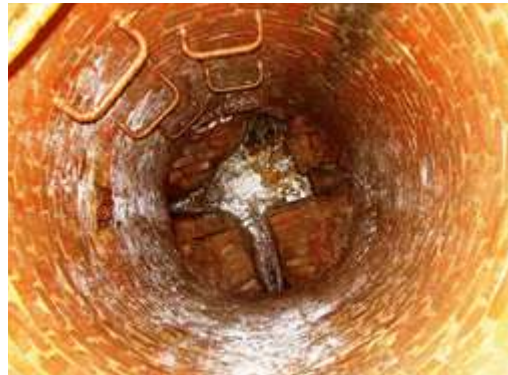
Top View

Corroded steps. Bench and Channel debris.

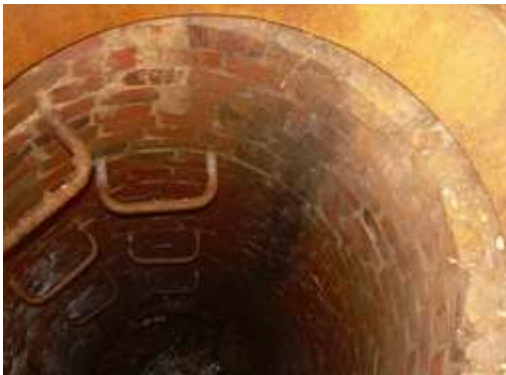
Defect

Frame offset. Adjustment deterioration and infiltration. Corbel and Barrel infiltration.

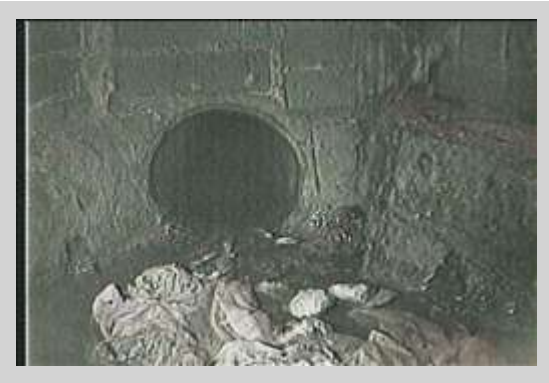
8 in. Circular Gravity Sewer Pipe Out @ 12 O'Clock

Deposits: ☐ None ☐ Mud ☐ Sludge ☒ **Debris** ☐ Grease

Infiltration: **Evidence** Pipe Seal Cond: **Unknown**

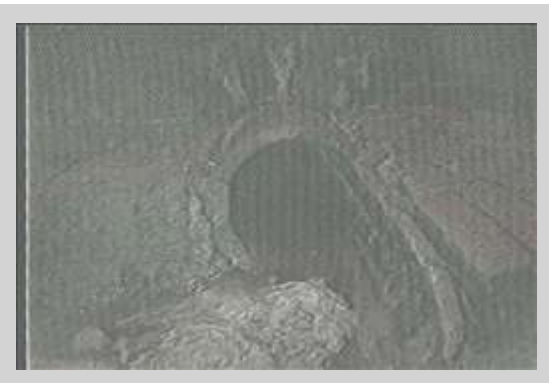
8 in. Circular Gravity Sewer Pipe In @ 2 O'Clock

Channel deterioration.

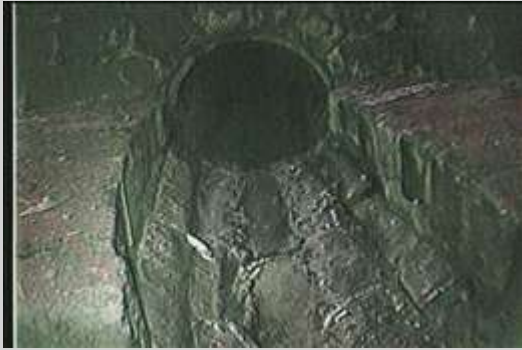
Pipe In @ 5 O'Clock

Infiltration: **Evidence**

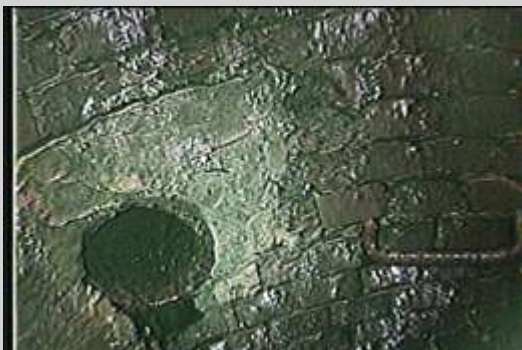
Pipe In @ 8 O'Clock

Barrel deterioration and infiltration.

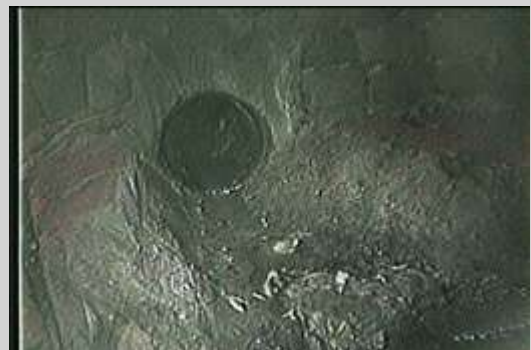
Drop In @ 8 O'Clock

Barrel deterioration and infiltration.

Drop Condition: **Partly Clogged**
